**ASBESTOS CONTAINING MATERIAL SURVEY REPORT  
OF  
MICHAELSON BUILDING**

**157 SOUTH BROAD STREET  
GLOBE, GILA COUNTY, ARIZONA 85501  
APN: 208-03-084**

**ATLAS PROJECT NO. 1052000242, PHASE 9**

**REPORT DATE: February 20, 2024**

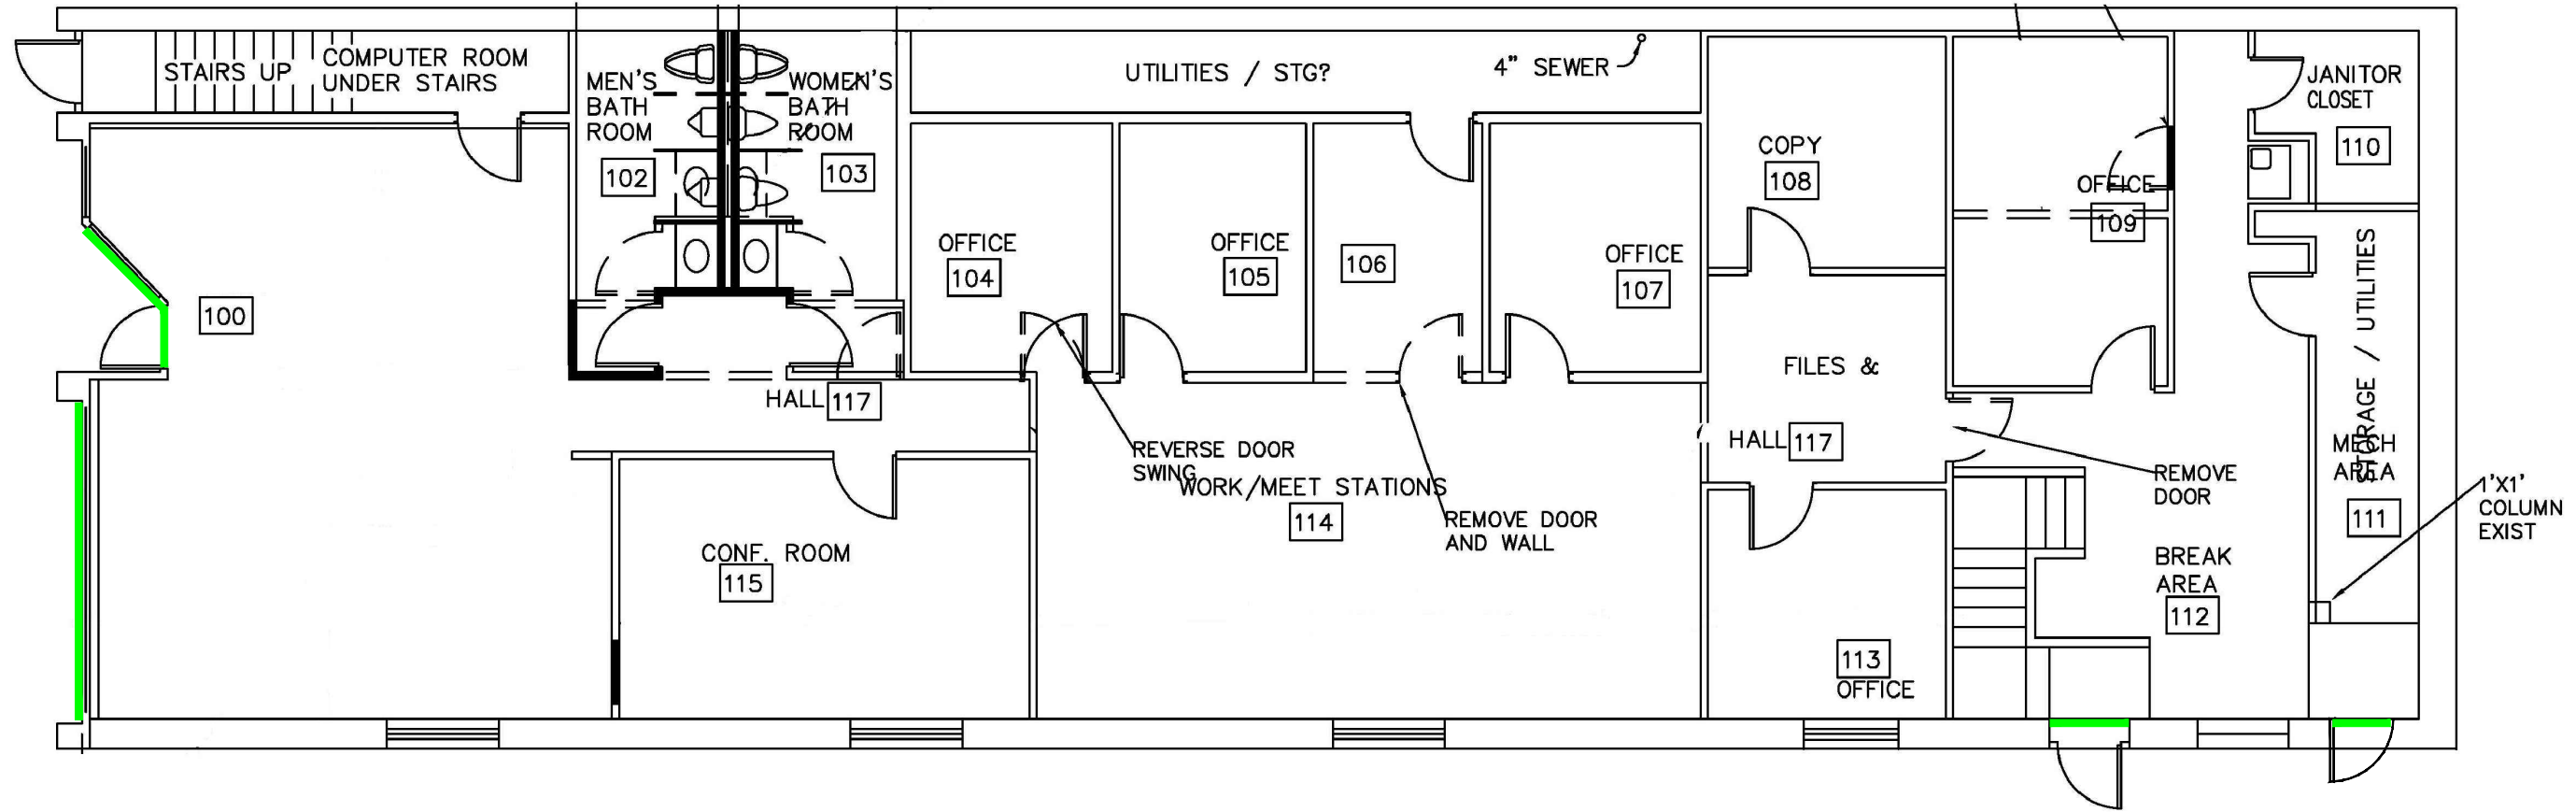
**ACM LOCATION MAP**  
**FIRST FLOOR**  
 MICHAELSON BUILDING  
 157 S. BROAD STREET  
 GLOBE, AZ

■ ACM M5 - EXTERIOR DOOR FRAME SEALANT (~6 S.F.)

Atlas recommends that identified ACM be removed by a qualified asbestos abatement contractor prior to the renovation and/or demolition of the Site building.
